# The Heritage Chimney Dilemma

Navigating seismic safety, council consent, and modern heating in historic New Zealand homes.

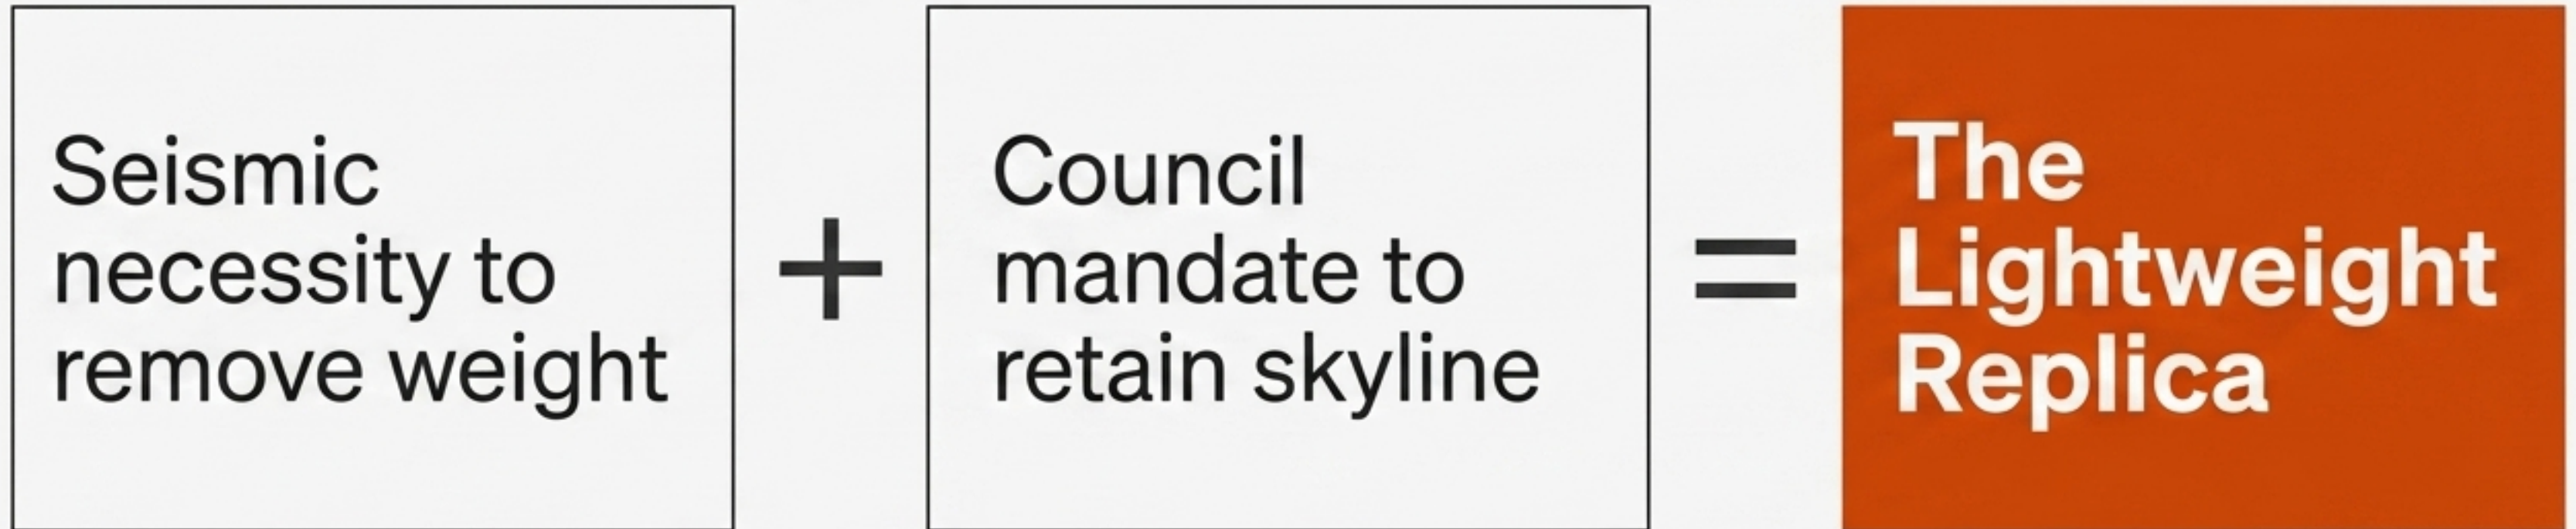
# The Heritage Mandate

Auckland and Wellington Heritage Teams frequently allow the removal of dangerous masonry down to the roofline, provided an exact replica is reinstated above the roof. The solution is an engineered illusion.
