Securing the Building Envelope

A diagnostic guide to chimney flashing, leak assessment, and structural preservation for New Zealand properties.

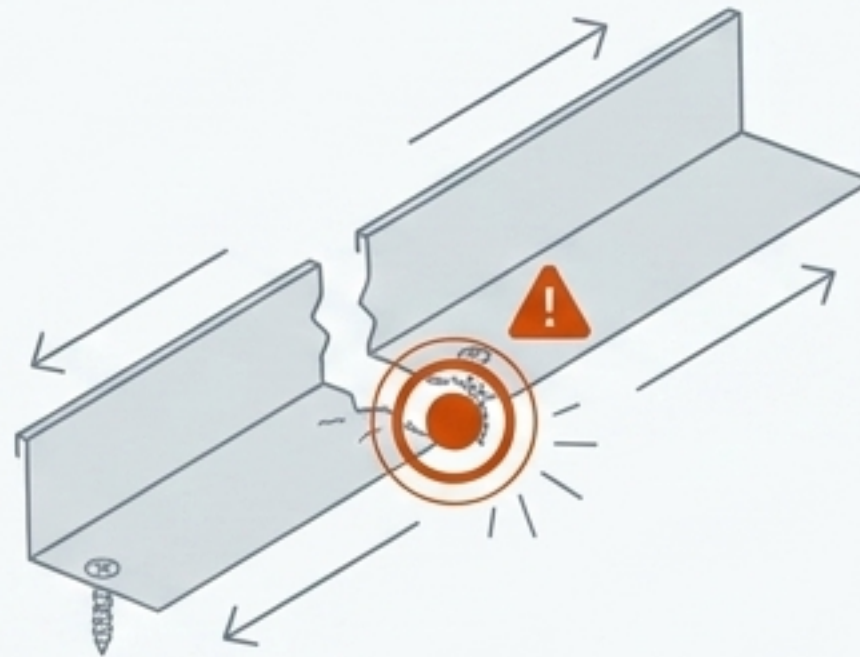
Thermal Expansion

Metal lengths over 12m require expansion joints. Repeated freeze-thaw cycles without expansion tolerance will tear primary fasteners.

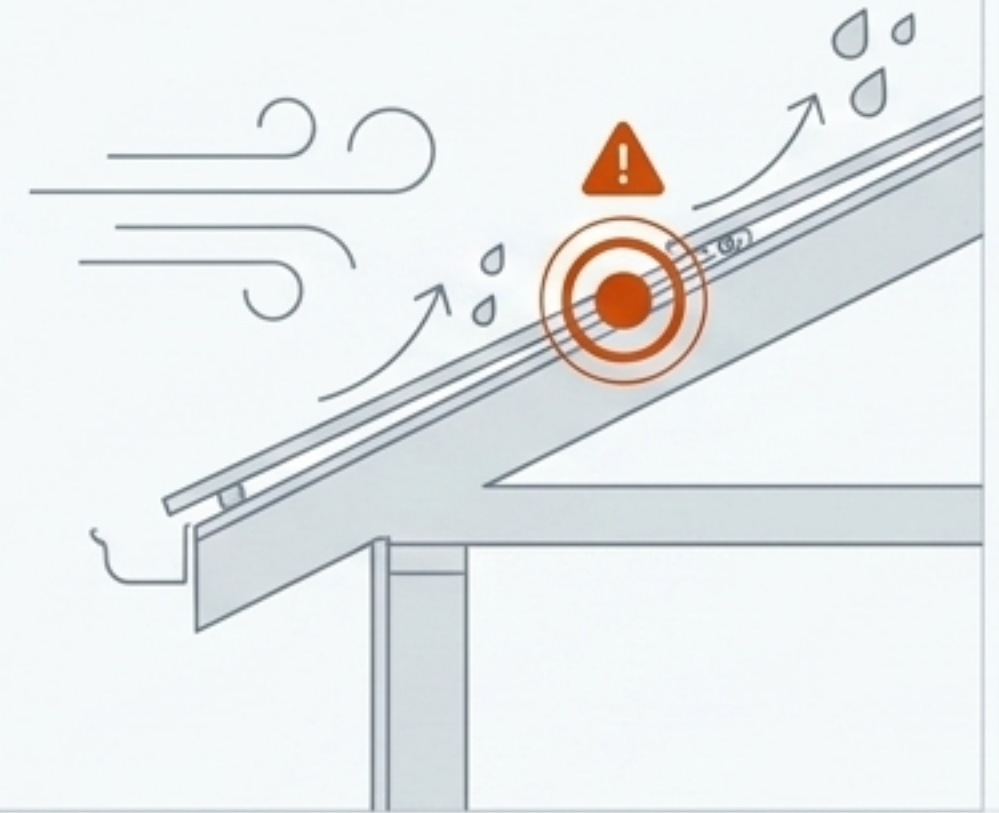
Wind-Driven Ingress

High NZ wind zones demand extreme fastening. Without compressible foam strips or a 3° minimum fall, wind drives moisture uphill.

- ❏ Maintaining a minimum 3° fall to prevent moisture ponding.
- ❏ Providing at least 150mm overlap where roof pitches change.
- ❏ Adjusting fastener frequency specifically for Low (1 per metre) vs. Severe (4 per metre) NZ wind zones.

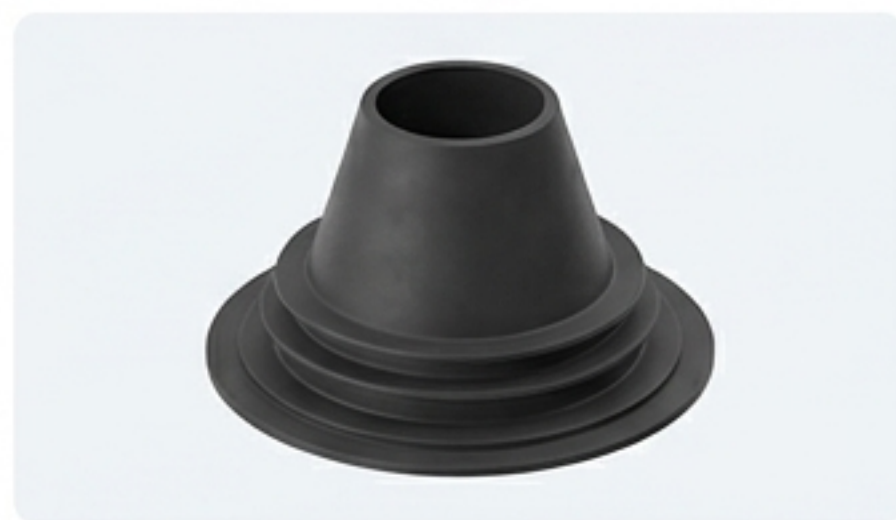
Polymer (Dektite/EPDM)

- Engineered specifically for pipe and flue penetrations.
- EPDM handles constant temperatures up to 115°C; Silicone up to 200°C.
- Isolates noise, accommodates roof vibration, and adapts to pitch.
